Testing of State Roadside Safety Systems Volume XI: Appendix J— Crash Testing and Evaluation of Existing Guardrail Systems

PUBLICATION NO. FHWA-RD-98-046

1. Report No. FHWA-RD-98-046		2. Government Accession No.	
4. Title and Subtitle TESTING OF STATE ROADSIDE SAFETY SYSTEMS VOLUME XI: APPENDIX J - CRASH TESTING AND EVALUATION OF EXISTING GUARDRAIL SYSTEMS		5. Report Date April 1999

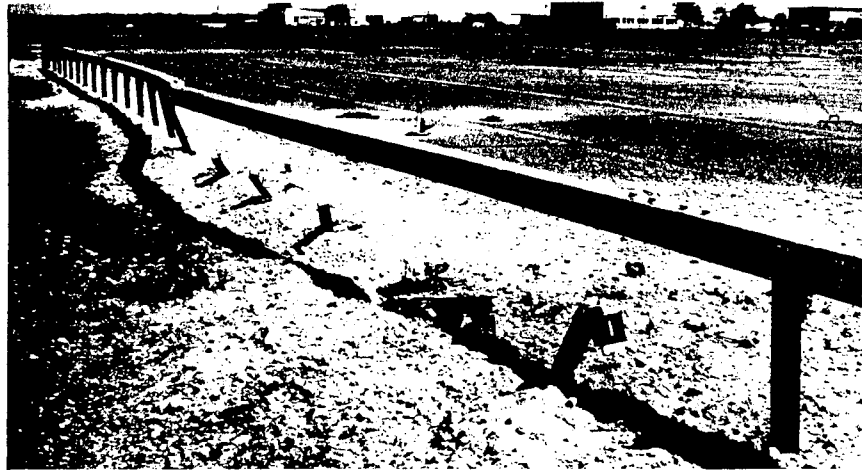
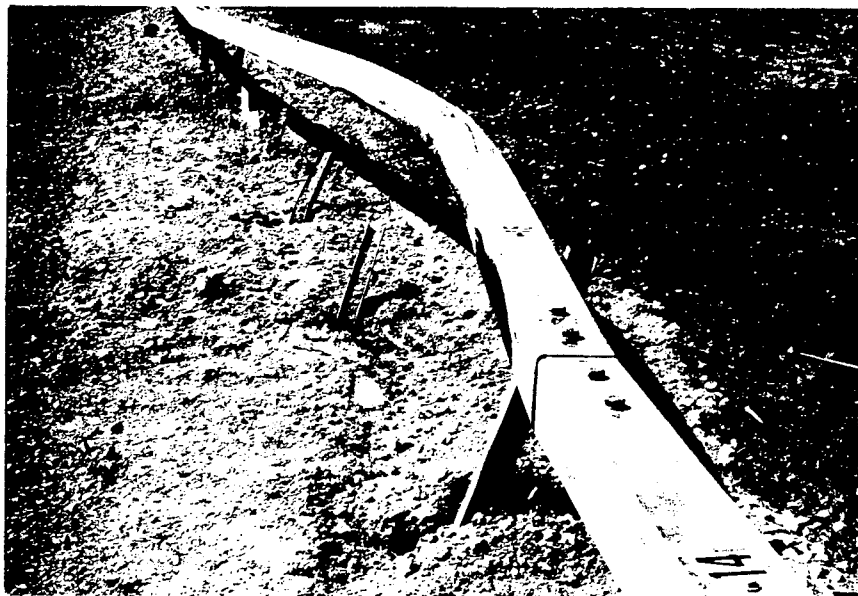
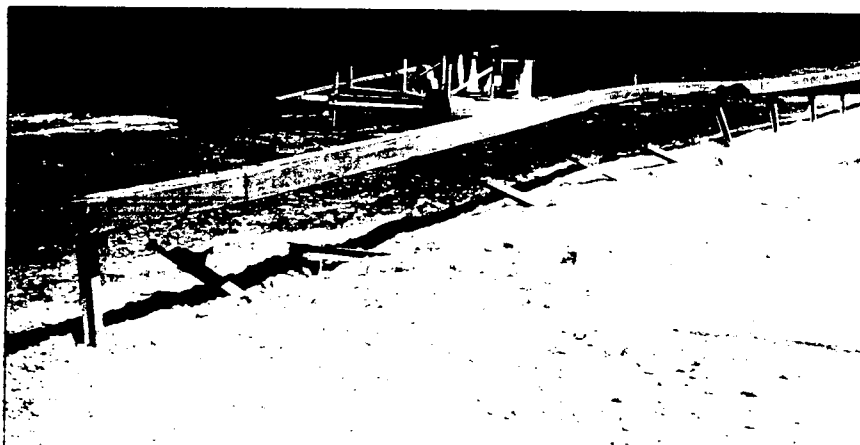
Figure 59. Box-beam (G3) guardrail after test 471470-33.

As seen in figures 59 through 61, the guardrail installation received moderate damage. There were tire marks on the face of the box-beam rail element from posts 15 through 21, and on posts 15 through 20. The box-beam rail element was separated from posts 16 through 20, and these posts were bent at ground level. The lateral deflections recorded at posts 12 through 22 are noted in table 3.

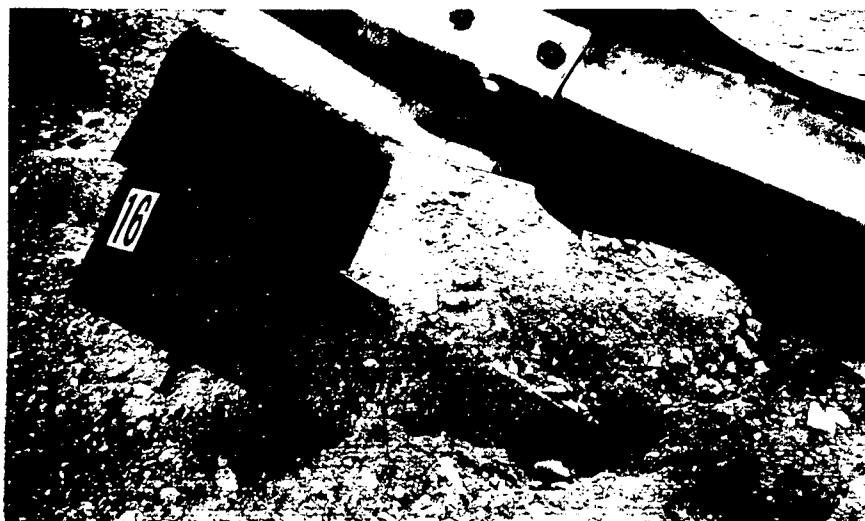
Figure 75. W-beam, wood-post (G4(2W)) guardrail installation after test 471470-26.

As can be seen in figures 75 and 76, the installation received moderate damage. The bolts were pulled out of the W-beam rail element at posts 15 and 16, and the blockout on post 16 was split. None of the posts broke off, but some posts were pushed back. The displacements of the posts are shown in table 4.

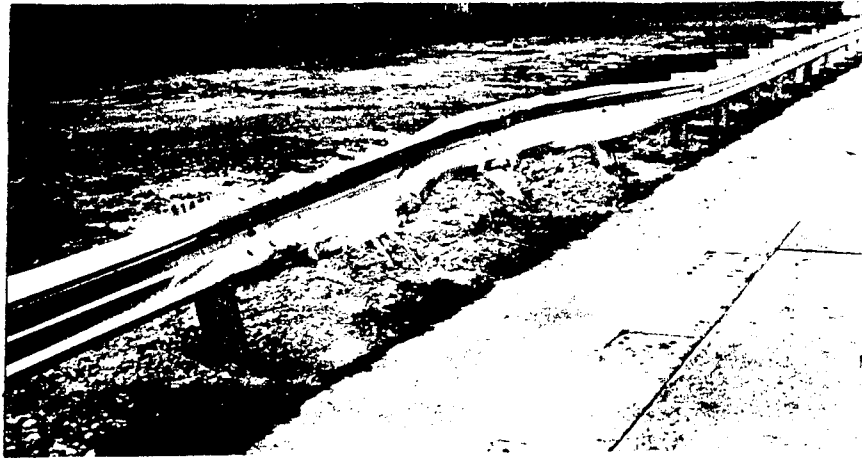
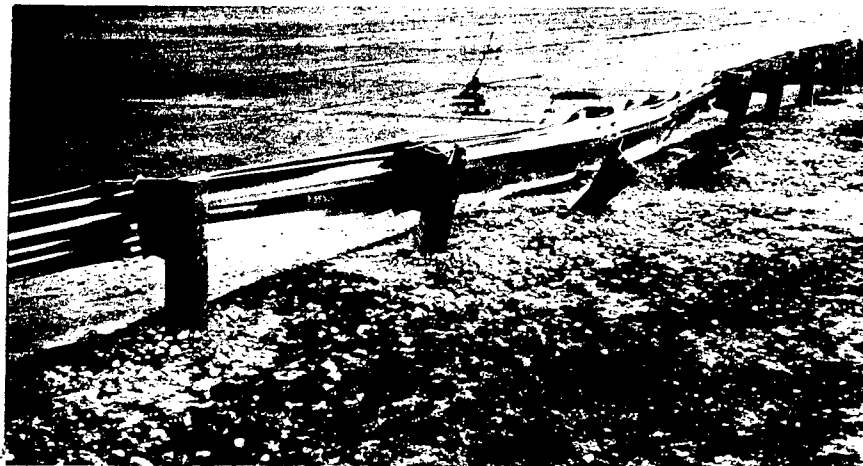
Figure 90. W-beam, steel-post (G4(1S)) guardrail installation after test 471470-27.

As can be seen in figures 90 and 91, the installation received moderate damage. The MELT anchor on the upstream end had pulled up slightly and moved laterally 44.5 mm (1.75 in). The buffered end nose was pulled off the end post (post 1). The bolts were pulled out of the W-beam rail element at posts 15, 16, and 17, and the posts and blockouts were bent. All the steel posts upstream of impact were disturbed, with measurable displacements as shown in table 5.

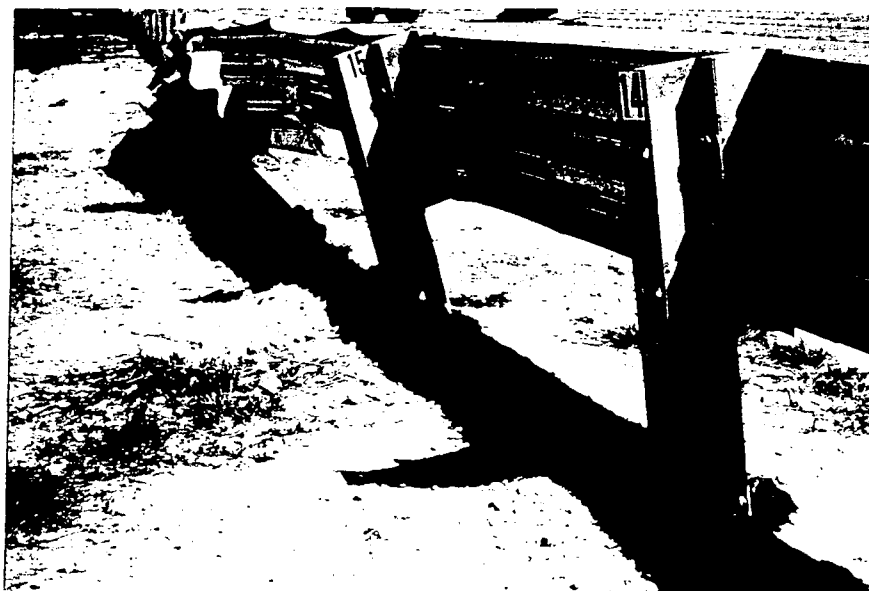
Figure 107. Three-beam guardrail after test 471470-31.

As seen in figures 107 through 109, the test installation received moderate damage. There were tire marks on the face of the thrie-beam rail element from post 15 through post 19, and on the face of posts 16 and 17. The thrie-beam rail element was separated from post 16, and the flanges on post 17 showed evidence of wheel contact. Posts 15 through 19 were twisted severely. The lateral deflections recorded at posts 13 through 20 are noted in table 6.

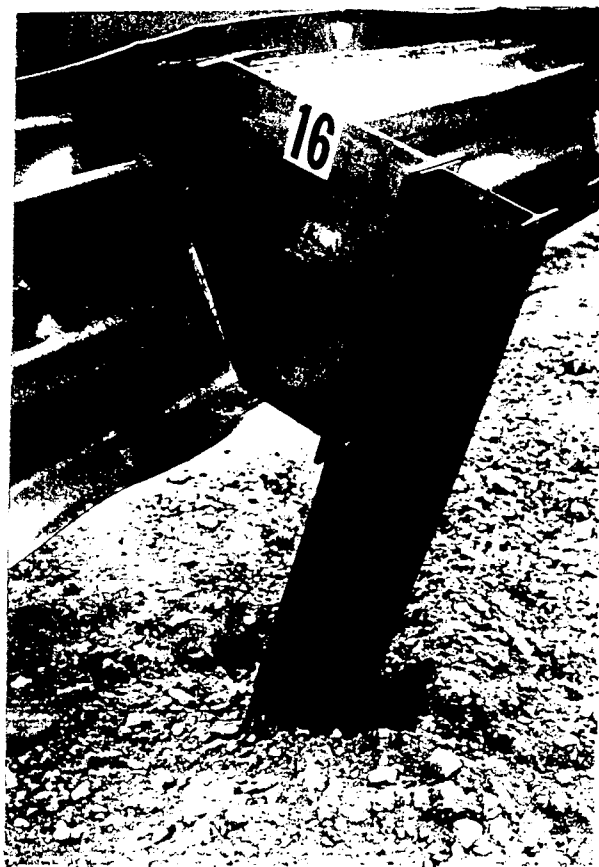
Figure 124. Modified three-beam galvanometer after test 471470-30.

As seen in figures 124 through 128, the installation received moderate damage. There were tire marks on the face of the thrie-beam rail element from post 15 through post 19, and on

the face of post 16 and the back side of post 17. The thrie-beam rail element was separated from post 17, and the flanges on post 17 showed evidence of wheel contact. Posts 16, 17, and 18 were twisted severely. The lateral deflections recorded at posts 14 through 20 are noted in table 7.
